# Hamilton Wharves Demolition

Liberty Industrial Primary Contractor	Economic Development QLD Client	Hamilton, QLD Location	February 2016 Start	July 2016 Finish
--	------------------------------------	---------------------------	------------------------	---------------------

## Project Overview

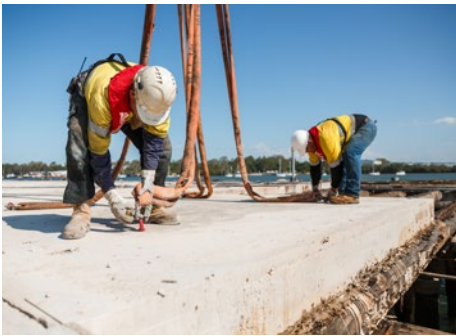
The project involved the removal of wharf structures including the removal of 18,000m<sup>2</sup> of concrete deck and substructure including timber bearers, joist and concrete head stocks, edge beams and the removal of over 1,900 piles. Liberty Industrial were awarded both Stages 1 and 2 of the project, delivering both stages concurrently to satisfy the client's tight scheduling requirements.

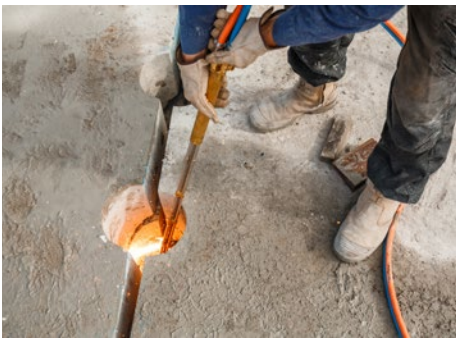
This required a complete rethink of the method while meeting the client's key requirement to reach project completion within the same time frame. We developed a method utilising large crawler cranes that could reach to the full length of the wharf while sitting behind the revetment wall and on the land side. Detailed lift studies were undertaken so that concrete panels and header beams could be cut and lifted in large sections to reduce preparation and rigging times. Chemset bolts were set into the slabs to enable lifting and lifts in excess of 30 tonnes were achieved. Complex rigging of the substructure timber was also undertaken so that large sections of the structure could be removed in single lifts.

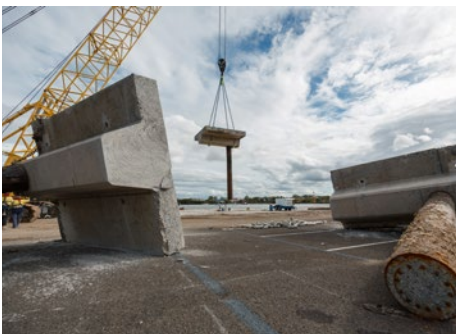
The piles varied from timber with concrete sleeves to hollow and concrete filled steel piles some of which exceed a metre in diameter. The 1,900 piles had to be cut a metre below the existing seabed depth rather than completely removed to ensure the ongoing stability of the existing seawall and river bed. Three full time dive crews dedicated to specific techniques were deployed to implement a range of innovative underwater cutting techniques. Tools and techniques included underwater dredging to expose the piles a metre below the sea bed, specialist Riggers to safely sling the concrete protective sleeves which existed on the majority of the piles, underwater hydraulic chain saw to cut the 1,900 timber piles and underwater diamond wire cutting equipment to cut steel and concrete piles.

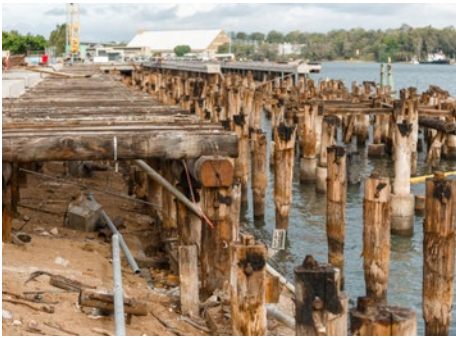
Liberty Industrial commenced discussion with a specialised dive contractor to undertake these works. Approximately 150 of the 1,900 piles were steel cased piles filled with reinforced concrete. The cutting of these piles, approximately eight metres below the water, was a critical consideration to ensure works could be completed on time.

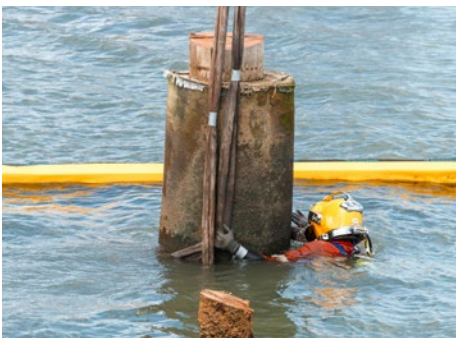
In consultation with the dive subcontractor we sourced a specialised underwater, hydraulically driven wire saw. These works needed to progress ahead of the slab deck and superstructure removal due to safety considerations and therefore approximately 30 diamond wire cables were acquired. This enabled the dive crew to move ahead of the works and leave the cables in-situ around the piles on the river bed (still joined to the superstructure). After the superstructure was removed the cables could be recovered and process repeated. Due to the tight program requirements we mobilised three separate dive crews so works could progress efficiently. During site works we discovered two 1,100mm diameter steel piles previously not identified at tender stage. The underwater diamond wire saw only had a throat opening of 900mm so a new method of removal needed to be developed. These piles were removed in two sections also due to their weight and the fact they were located on the outer edge of the wharf structure. The outer steel casing was originally cut with underwater torches to expose the reinforced concrete. The concrete was then hammered back (underwater) and the reinforcement removed so that the diameter of the pile was reduced to less than 900mm and the diamond wire saw could be deployed.

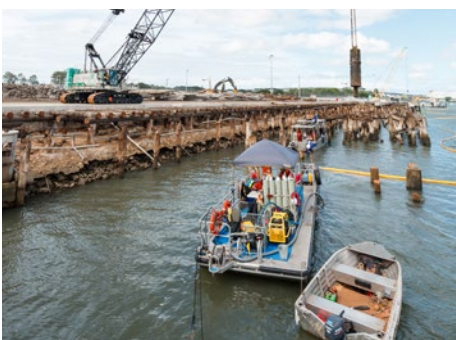
When dive works commenced the crews identified large numbers of broken piles and other debris scattered along the river bed. None of these materials were identified in the pre-demolition hydrographic survey. We acquired a large number of additional lifting slings that the divers could move ahead and sling this debris in an efficient manner so that they were not waiting for the crane to slew back into position. Once a substantial quantity of debris had been rigged the crane and divers moved swiftly along the work area lifting the debris in an efficient manner that ensured the program remained on track.

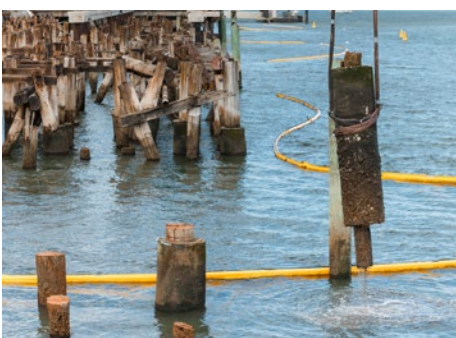
Stringent environmental controls were implemented including dedicated booms and silt curtains to prevent any discharges into the river during dredging works. Additional controls such as vacuuming during saw cutting and dust suppression measures employed during hammering to further limit any discharges into the river.
