# Omega Tower Demolition

**Liberty Industrial**  
Primary Contractor

**Department of Defence**  
Client

## Project Overview

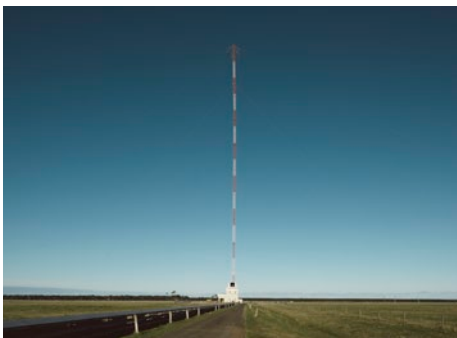
Standing 432 metres (1,418 ft) high, the Omega Transmission Tower in Darriman, Victoria was the tallest structure in the Southern Hemisphere until its demolition on 22 April 2015. Contracted by the Department of Defence to carry out the demolition, Liberty Industrial used controlled explosive techniques to bring the redundant Naval communications tower to the ground.

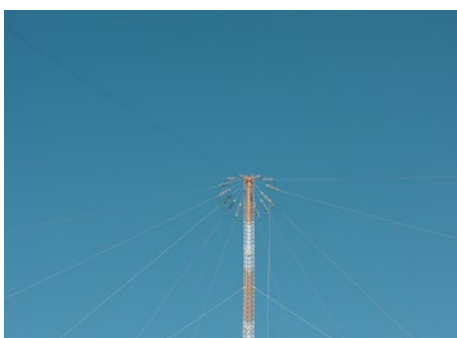
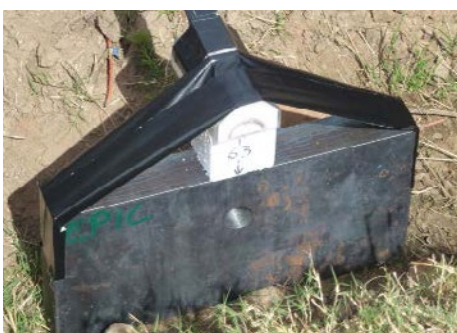
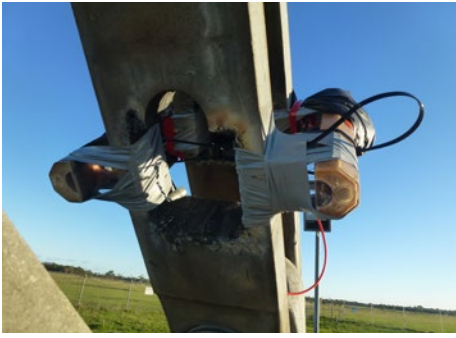
We tested the available explosives on steel plates fabricated to replicate the cable support stay plates we were planning to sever with the cutting charges to determine exactly what depth they could confidently cut through.

After the testing days, we were satisfied that we could at least sever 50mm thick plates with the Comp B explosives charges. However, to ensure that we had some redundancy in the charges, we decided to undertake preparatory oxy cutting on the cable stay support plates to ensure we had a maximum of 40mm thick steel to cut. With some of the cable stay support plates up to 80mm thick at the outer most support, we utilised GHD Engineering, our preferred Structural Engineering company, to complete a full structural review on the tower and its support stays, to

develop a preparatory cutting scheme that ensured we had no steel thicker than 40mm to explosively cut, whilst ensuring the tower remained structurally sound until the cutting charges were initiated.

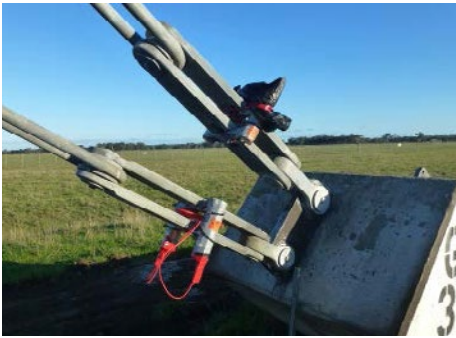
In the days prior to the implosion, oxy cutting works were carried out to prepare the twelve designated cable support stay plates. Precision and accuracy were paramount to ensure the tower remained structurally sound and to prevent an uncontrolled collapse. We also carried out the controlled release of one of the 1.5 kilometre aerial cables to prevent collateral damage to existing buildings that were to remain on the site. We utilised a second aerial cable which we had released from the opposite side of the tower and a 36t excavator to secure the tensioned cable, before separating it from its anchor.

We were able to control the release of the cable by tracking it in with the excavator to ensure it was clear of the retained buildings. All other guy and aerial cables were retained to maintain the structure's stability. The day before the implosion, the explosives were affixed to the twelve designated anchor plates and all necessary checks were carried out in line with the Blast Day Management Plan. Two security guards remained onsite throughout the night to ensure the explosive's remained secure.

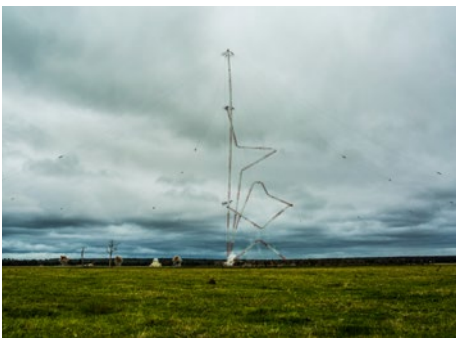
Comprehensive planning, calculated engineering and careful preparation delivered a successful outcome for Liberty Industrial's project team, with the implosion precisely executed and the structure safely grounded in a matter of seconds, reacting as planned and anticipated. The cutting charges successfully severed the plates, releasing the guy cables and causing the lattice truss tower to destabilise and collapse upon itself in four large sections.

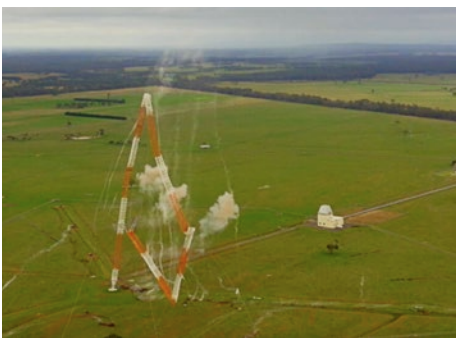
Once all explosive charges were accounted for, oxy cutters moved in downsizing sections of the structure unable to be processed mechanically. A 36t Volvo Excavator with shear, grab, and bucket attachments and a 30t Komatsu Excavator with grab and bucket attachments were mobilised to process scrap materials clear the site of debris before removing the material from site for recycling. The team recovered more than 700 tonnes ferrous metal and 37 tonnes non-ferrous metal, which accounted for 97% of all waste material.

Once the site was clear of debris, a 36t Volvo Excavator with a bucket attachment was used to decontaminate the area that surrounded the felled tower, removing 100mm of topsoil from the area as a precautionary measure, to ensure the site was free of any lead based paint contaminants that may have been released from the structure's lead paint coating exterior with the impact of the collapse. Soil test results were provided prior to demobilising to certify the area was free of any lead paint contamination. The 432m Omega Tower is the tallest structure demolished in the Southern Hemisphere to date.
